Destructive Dust Devils In The Las Vegas Valley On May 7, 2012

**Chris Stachelski/Forecaster
Faith Borden/Warning Coordination Meteorologist**

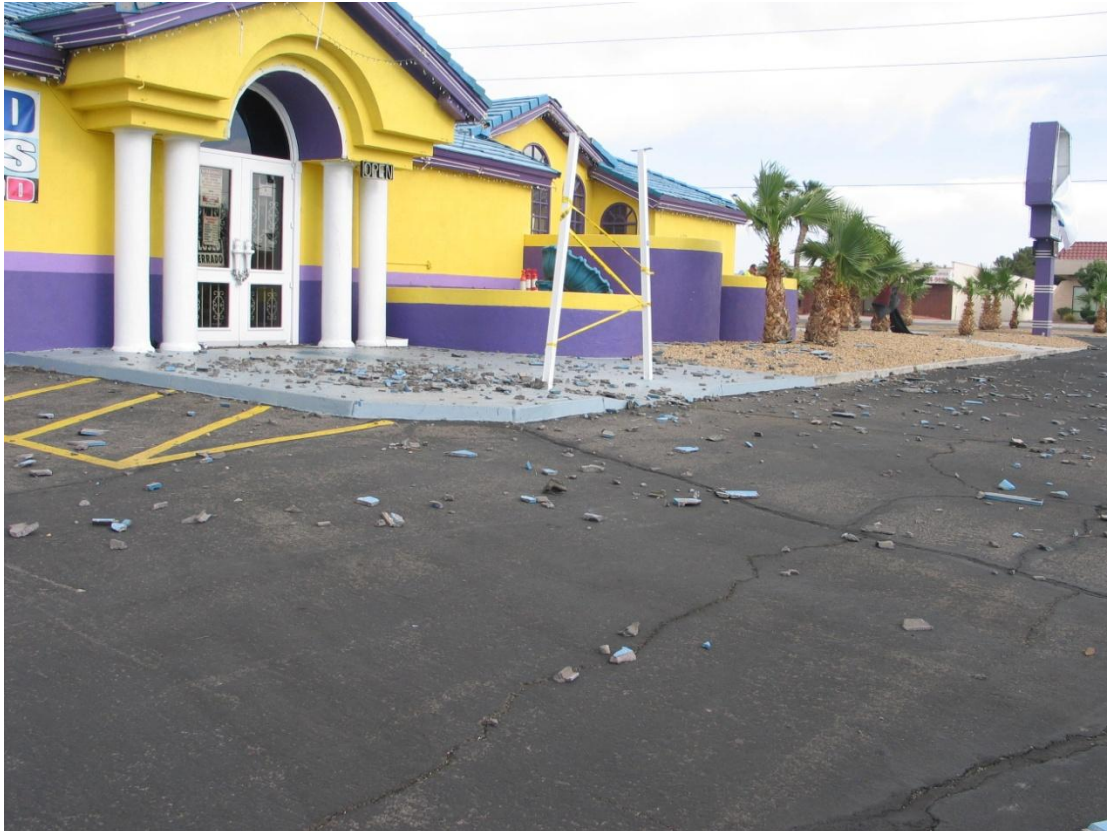
Damage to the La Costa Grill from a dust devil. Photo credit: NWS Las Vegas.

One dust devil developed just east of the intersection of Eastern Avenue and Flamingo Avenue and plowed into the La Costa Grill around 3:30 PM. An area of tile shingles was removed from the west side of the building, a large ceramic fountain was toppled and part of a sign was damaged. In addition, an awning from the building collapsed.

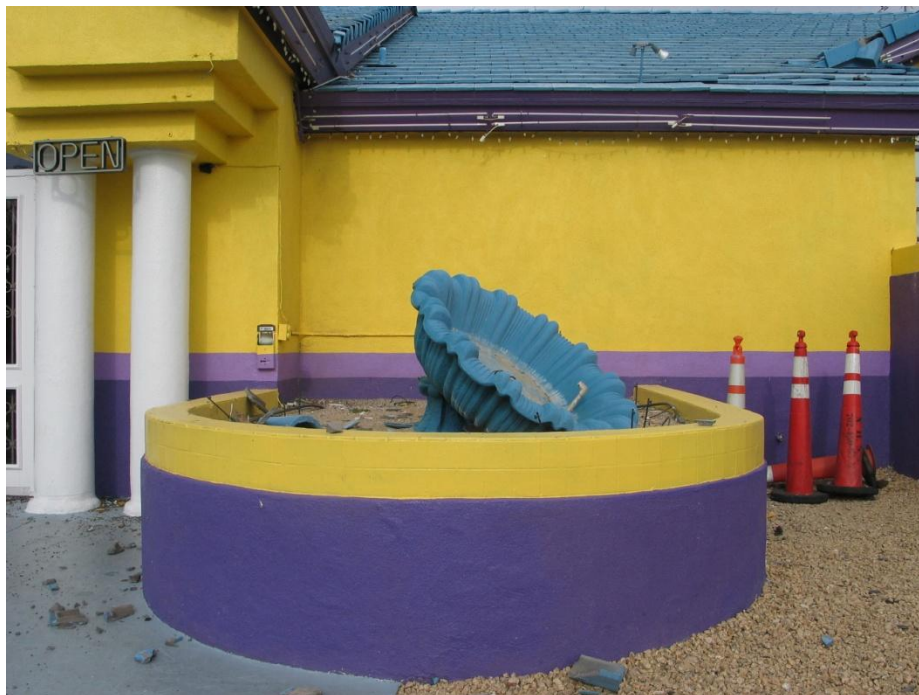
Cracked fountain at the La Costa Grill. Photo credit: NWS Las Vegas.

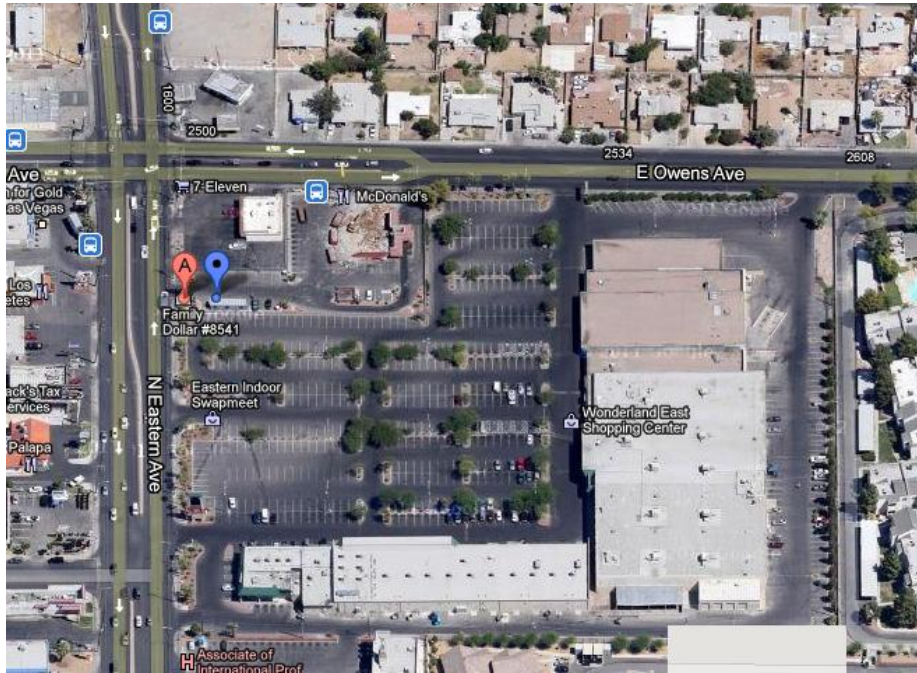
Google Earth map of the shopping center where Family Dollar was damaged.

A second dust devil formed near Eastern Avenue and Owens Avenue and moved across the parking lot of a strip mall where it uprooted trees before hitting the Family Dollar Store at about 3:30 PM. An awning on the store was struck and resulted in part of the roof of the store being torn off. In addition, shingles were damaged on the roof of a nearby apartment complex.

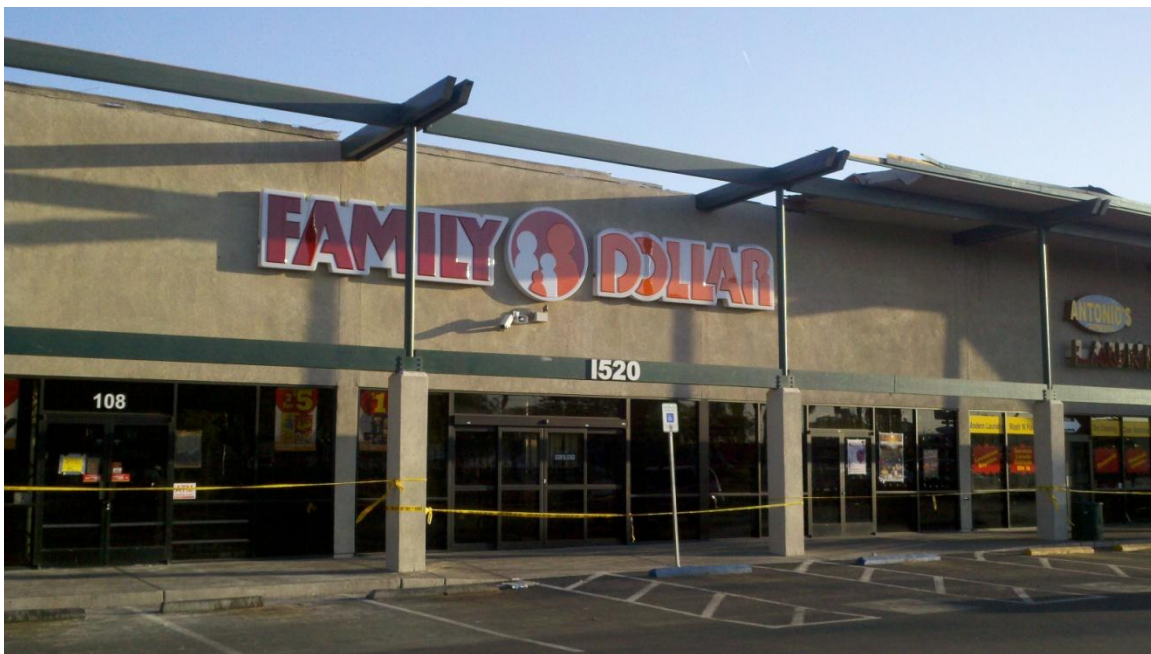
Damage to the roof and awning of the Family Dollar store near Owens Avenue and Eastern Avenue. Photo Credit: NWS Las Vegas.

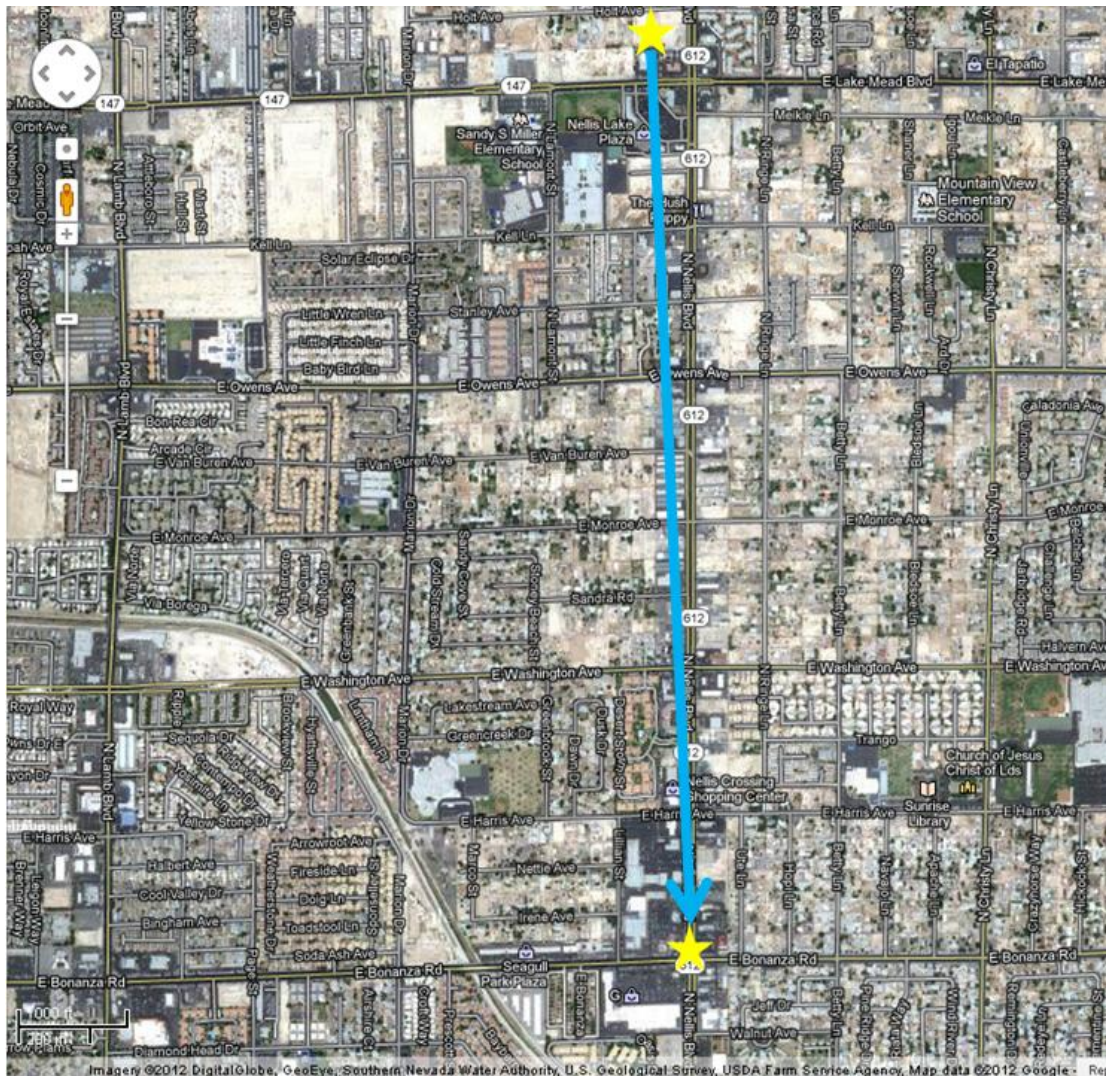
Google Earth map showing the track of a dust devil near Nellis Boulevard (blue arrow). One yellow star shows the dirt lot where a dust devil formed near Lake Mead and Nellis while the second star the approximate location of where the dust devil ended near Bonanza and Nellis.

A third dust devil was photographed in a vacant dirt lot just west of the intersection of Lake Mead Boulevard and Nellis Boulevard. Based on an interview with an employee of Pioneer Loan Center, the dust devil formed at this location and then moved south along Nellis Boulevard. Using footage from a security camera at the Pioneer Loan Center, the start time of this dust devil was estimated at 1:37 PM, three minutes earlier than it hit the loan center at. Several employees of businesses in this area were interviewed and provided valuable additional information on the time, track and damage from this dust devil. After forming in the lot northwest of Nellis and Lake Mead, the dust devil traveled over the Nevada State Bank where it tore shingles off the roof. The dust devil then passed over a parking lot to the south where several cars were damaged, mainly from flying debris. Some cars had windows cracked or broken in. The dust devil passed through an apartment complex removing numerous shingles from roofs. The next business that saw damage occur was at the Pioneer Loan Center

where the dust devil knocked down a cinderblock wall and a light pole. Several telephone poles along Nellis Boulevard were also damaged. The loan center employee said security camera footage showed the dust devil lasted about 35 seconds at that location. After moving south of this area, the dust devil continued but appears to have weakened. Area business employees reported seeing the dust devil on the ground as far south as the area of Bonanza Road and Nellis Boulevard. In all, the dust devil traveled approximately 8000 feet or one and a half miles. This is an unusually long track for a dust devil.

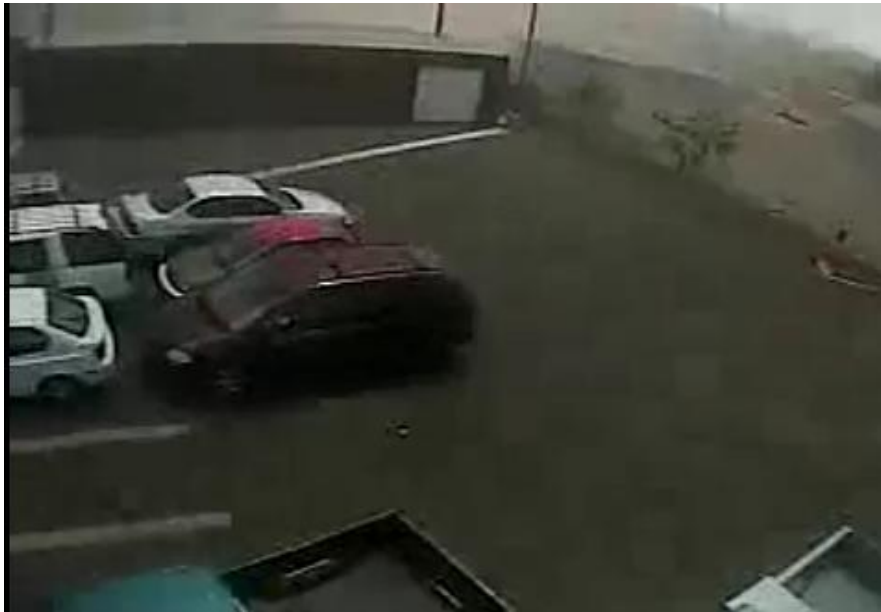
Security camera footage of dust devil near Nellis Boulevard and Kell Lane.
Courtesy: Pioneer Loan Center.
